Manufacturing Innovation Insider Newsletter

Engineered Plastic Cooling Towers Impervious to Caustic and Costly pH Factors

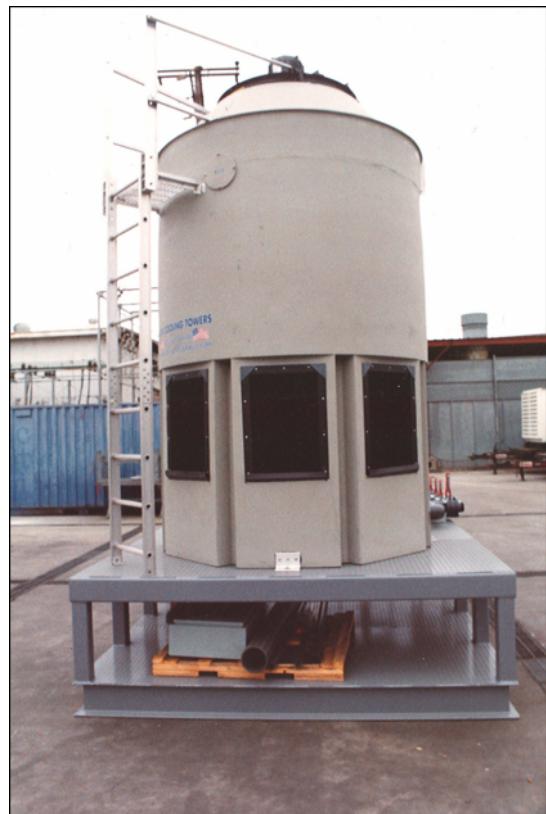
Engineered plastic cooling towers are ideal for harsh environments. They are impervious to salt air and waste products that can often be found in the air in many industrial areas.

On the other hand, plastic cooling towers are also ideal for harsh environments. They are impervious to salt air and waste products that can often be found in the air in many industrial areas. They are also impervious to a variety of minerals found in extremely hard water.

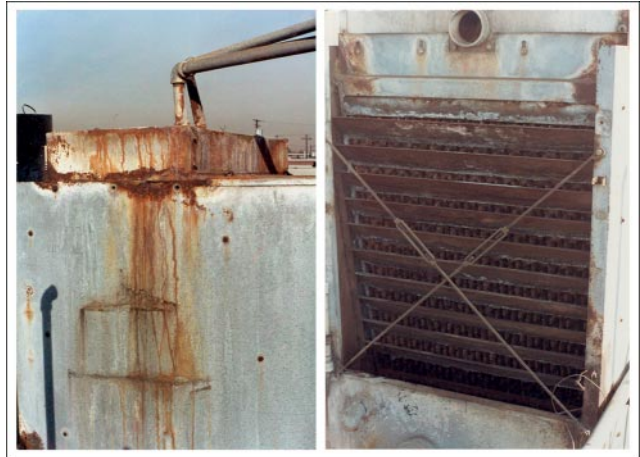
Metal-clad cooling towers are literally being eaten alive by harsh environments. They are attacked internally by process chemicals and externally by environmental elements.

“Metal-clad cooling towers are being eaten alive by harsh environments,” says “Jim Ruddy, President of Proprietary Systems, Inc., Westlake Village, California. “They rust and corrode all the time. They are attacked internally by process chemicals and externally by environmental elements. Metal tower technology is antiquated and very expensive to maintain. Metal towers can also corrupt processes, causing headaches that can cost thousands of dollars many times over.”
